HANGAR FLOOR SETTLEMENTS AT THULE AIR BASE, GREENLAND

TECHNICAL REPORT NO. AFWL-TR-69-122

March 1970

An investigation has been made of hangar floor settlement problems at Thule Air Base, Greenland. Inspection of existing instrumentation and soil-cooling systems were accomplished. Results of this inspection are presented. Existing temperature sensors were found to be in excellent condition; however, readout capability was poor. Pumping of ground water has removed no fines from the fill which might have caused settlement. Major cause of settlement was found to be thawing which has contributed to settlement. Duct blockages in the soil-cooling system has also allowed thawing to occur resulting in settlement. Recommendations are made to control further hangar settlement. Blocked ducts in the soil-cooling system should be cleared on an annual basis. The water table should be lowered by lowering the water level in nearby Lake Eddy. Recommendations were also made to improve instrumentation in order that effective operation and maintenance procedures for hangar foundation could be developed.

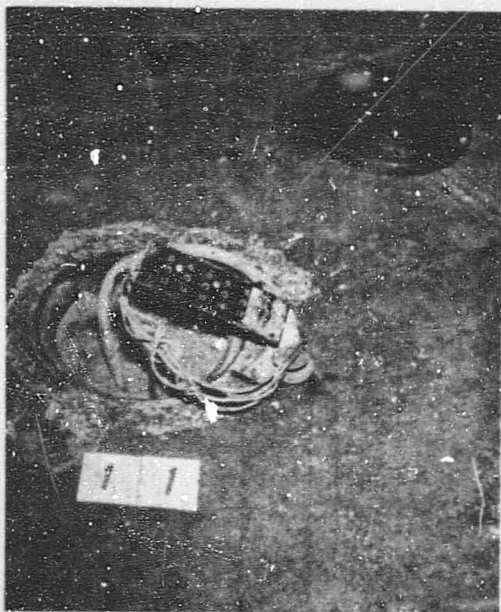
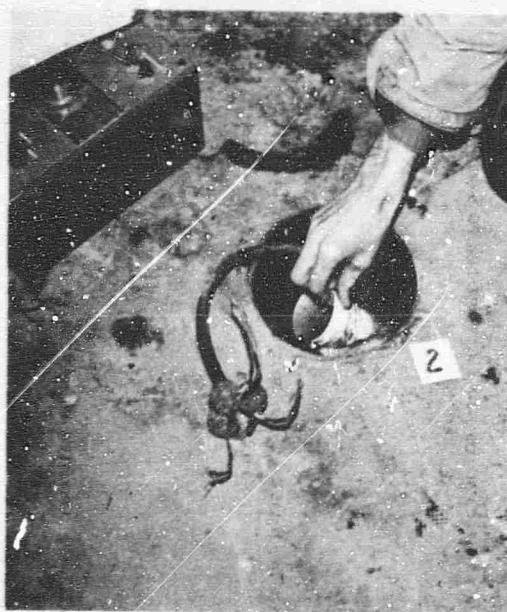
Figure 4. Present Condition of Typical Thermocouple Assemblies

All thermocouple assemblies in hangars 1 through 10 were inspected. The location of each assembly is shown in Appendix I. Many of the cover plate support brackets for floor assemblies were broken. New brackets were fabricated and welded in place. Now all covers function as initially intended. Upon removal of several cover plates, the assemblies below were found immersed in liquid. The recess was bailed dry, but it can be expected that in the future liquids will inadvertently enter and additional bailing will be necessary. New assemblies should be watertight.

When possible, switches and panel boards were cleaned and reconnected. Several damaged panel boards and corroded switches were removed. Continuity was established both before and after disconnecting each wire and tags were installed. The present condition of all assemblies is listed in table I. Photographs of typical switch and panel board assemblies are shown in figure 4.

All thermocouples were read with a Leeds and Northrup No. 8686 precision potentiometer. An ice bath reference junction was used. Although several switches and panel boards were damaged, the sensors themselves were in excellent condition. All 100 thermocouples in hangars 1 through 9 were operable and of the 428 sensors in hangar 10, only five could not be used. Overall, more than 99 percent of the sensors were functioning, though many were over 15 years old. Even those located directly below the 2.2-foot deep settlement depression in hangar 10 were functioning.

Where switches and panel boards have been removed, measurements must now be taken by holding the bare wires against the copper-constantan plug of the jumper cable. This scheme is slow and tedious and it is suggested that replacement switches and panel boards be secured for these assemblies. Since most panel boards in hangars 1 through 9 are badly corroded, it is suggested that they be replaced under Phase II of this study if pursued.

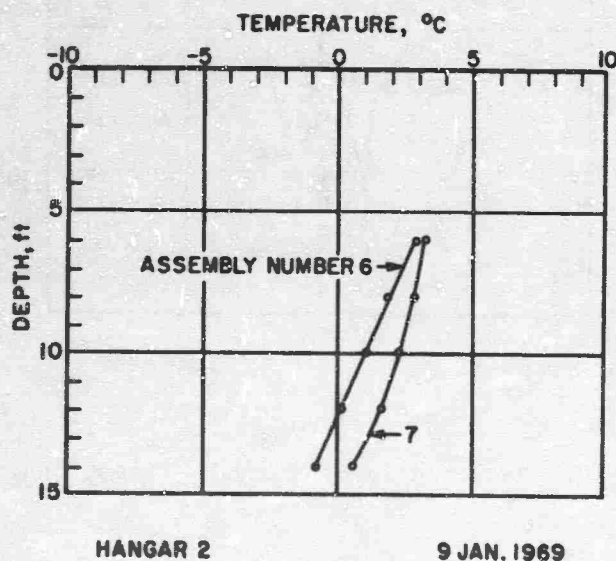
Figure 12. Measured Temperature Profiles, Hangar 2

The two thermocouple assemblies in hangar 2 indicate that on 9 January along the north-south centerline at distances of 18 and 45 feet from the south well, the depth of thaw was about twice that observed at similar positions in hangar 1 (figure 12). Hangar 2 has suffered severe floor settlement and the increased depth of thaw there is further evidence that the distress is the result of thawing frost-susceptible native soil. The 3-1/2-foot deep depression in hangar 2 is not centered in the western half of the hangar but is more nearly on the centerline. This is strong evidence that pumping has been a major cause of localized thaw deepening since pumping in that hangar has been conducted from both the northwest water well and one located near the center of the hangar. Ground water pumping from under other hangars has been accomplished from the northwest water well and the center of the settlement depression for these hangars has consistently formed below that area.

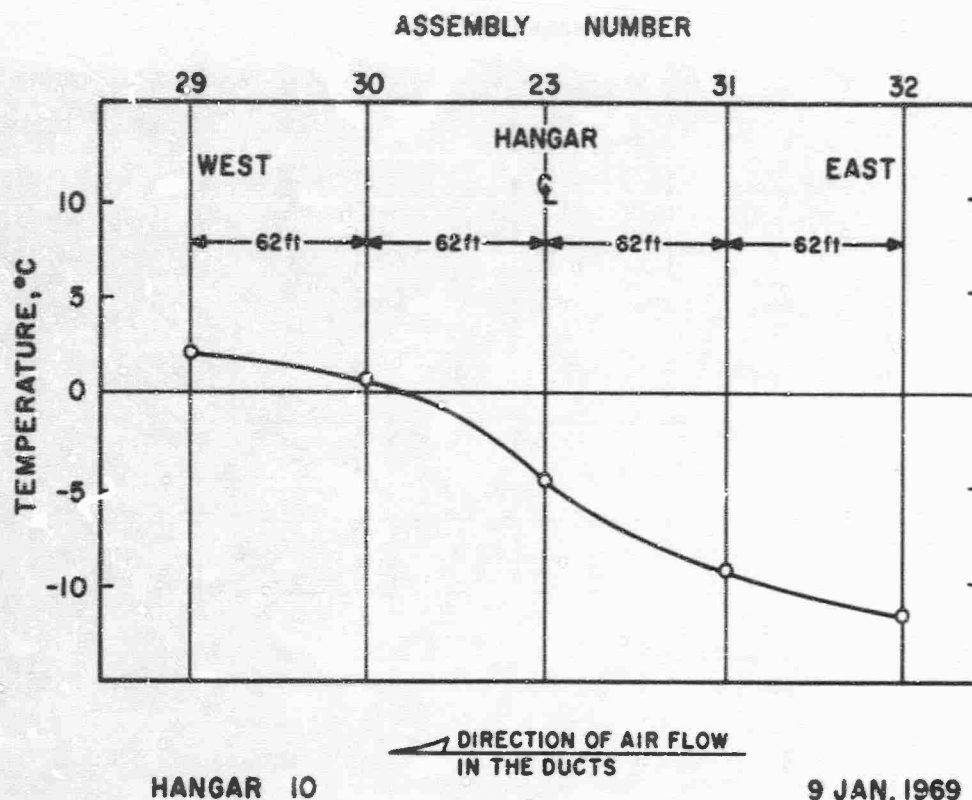
Figure 17. Measured Duct Temperatures along the East-West Line of Instrumentation, Hangar 10

A decreasing effectiveness of the downwind end of the soil-cooling ducts is also evident in hangar 10 (figure 17). Air was flowing through the instrumented duct when the measurements in figure 17 were obtained. Thaw has progressed to

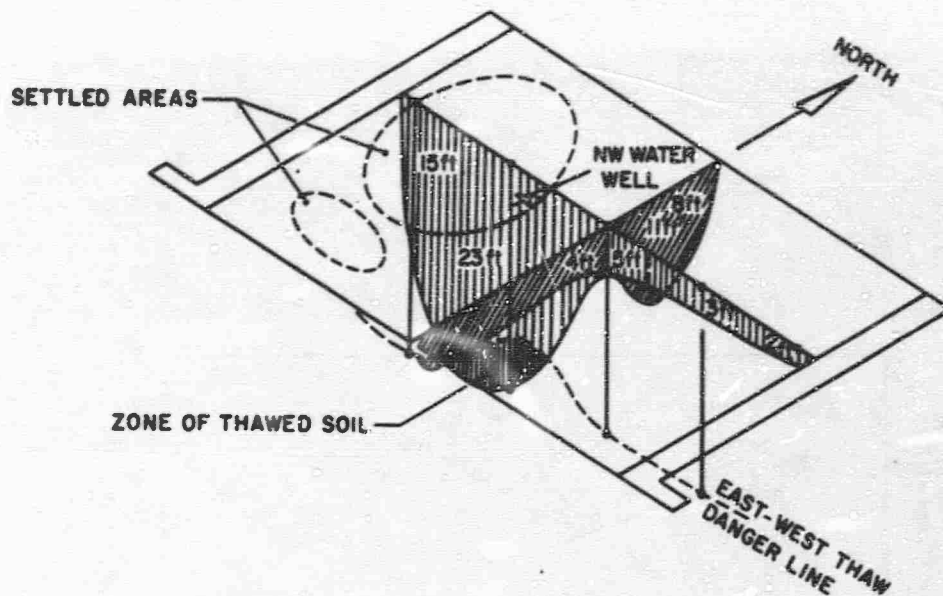
Figure 18. Measured Thaw Penetration, Hangar 10, 9 January 1969

a depth of 23 feet near the northwest water well as shown in figure 18. It is felt that concentration of ground water flow by pumping is responsible for localized deep thaw penetration near the well. The soil borings obtained in that hangar permit locating the thaw line and the zone of thawed native soil. The center of the large depression dish is about 2.3 feet below the hangar floor at the southeast corner.

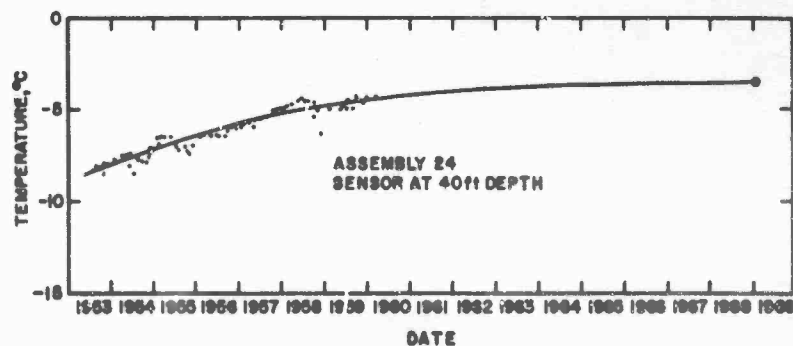
Figure 19. Progressive Warming of Soil 40 Feet below Hangar 10

Warming is also present under hangar 10. Sufficient data are available to indicate that the rate of warming at depth is decreasing as shown on figure 19. This indicates that a steady state heat flow condition is being approached and the rate of thaw penetration is slowing down. This is further documented by elevation surveys conducted by the personnel of the Base Civil Engineering Division which indicates that the rate of floor settlement in hangar 10 has decreased since 1963 (figure 20).

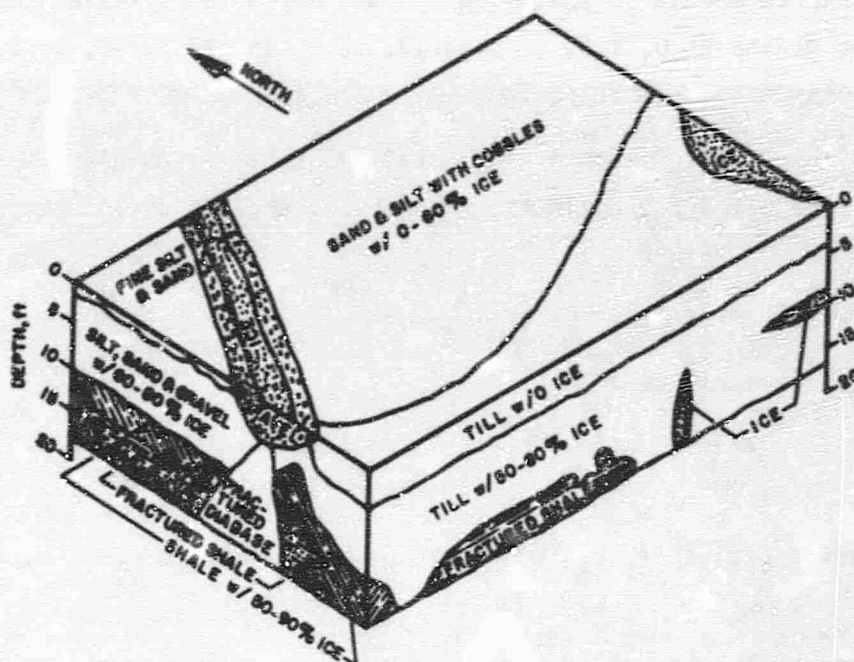
Figure 21. Isometric View of Native Soil below Hangar 10

An isometric sketch of the soil conditions below hangar 10, based on visual examination of the side of the excavation made when installing piles, is shown in figure 21. The complicated nonhomogeneous soil system and isolated wedges of ice indicate that an extensive subsurface exploration program would be required to clearly delineate soil and ice boundaries within the native material. It is felt that the cost of a comprehensive soil investigation program would far outweigh any design refinements that might result from the additional information collected. However, a few checks of the depth to native soil would be helpful for corrective purposes and additional subsurface temperature information is desirable for more effective monitoring of the performance of hangars 1 through 9 once modifications are made.
